Title: CONTINUATION SURVEY OF YAGS 39:40 (8/18/56)

18 August 1956

MEMORANDUM

Subj: Contamination Survey of YAG-39 and YAG-40; report of

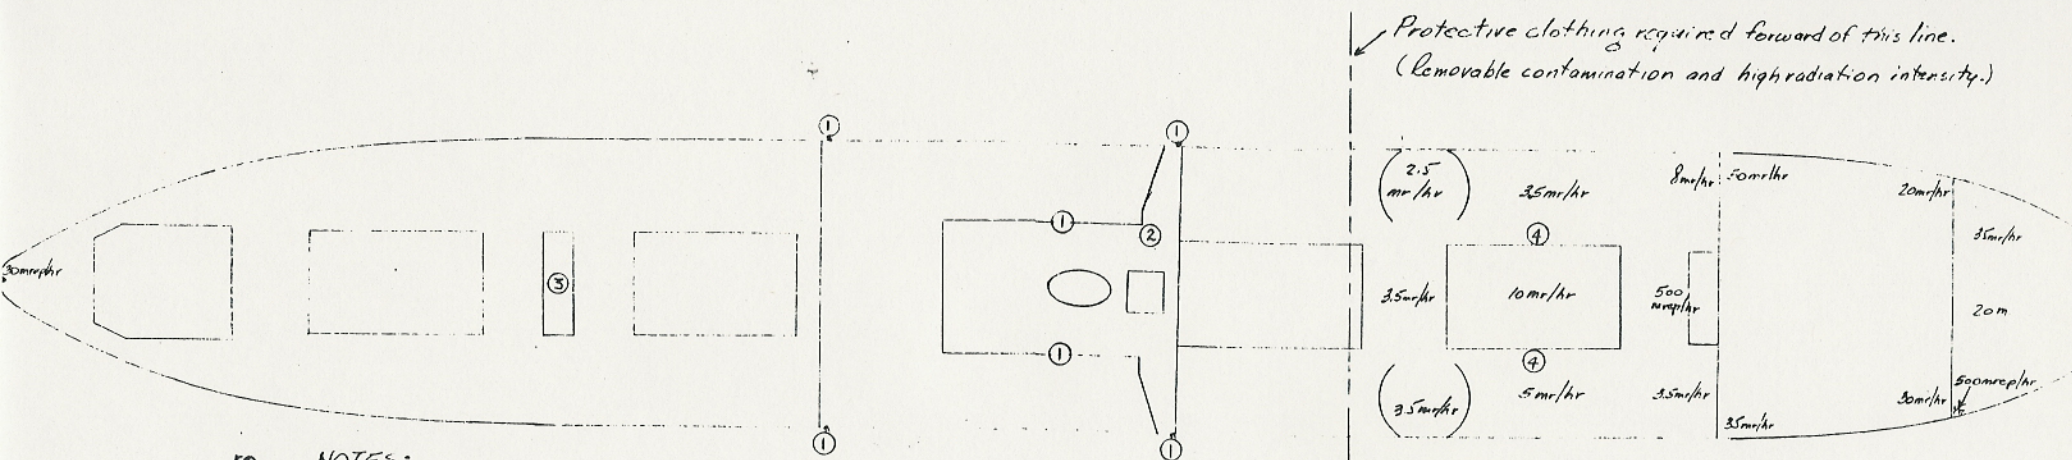
ENGL(1)

1. Enclosures (1) and (2) show the radiological status of the weather deck areas of this vessel.
2. Weather deck surfaces forward of the deck house over Hold #3 have not been decontaminated by ships force. Radiation levels vary from 3.5 mr/hr to 35 mr/hr at a distance of three feet from the surfaces, and from 5 mr/hr to 400 mr/hr at close proximity. Evidence of coral particles (fixed contamination) which has collected in normally inaccessible areas such as corners, crevices, in and around metal bracing, under piping, around the underside of the Hold #2 hatch cover near the piping, etc., results in the high readings found.

- ① Overboard drains and scuppers - Average 1.5 to 5 mrem/hr at 3' & 3 mrem/hr to OAR sink (on) at close contact.
- ② Antenna Mast - Rusty wire cable - 150 mrem/hr - (Should dispose of cable to reduce average level.)
- ③ Base of mastpost and boom area - 20 to 200 mrem/hr at close contact.
- ④ In and around piping in this Hold #2 area - close contact readings to 500 to 750 mrem/hr.

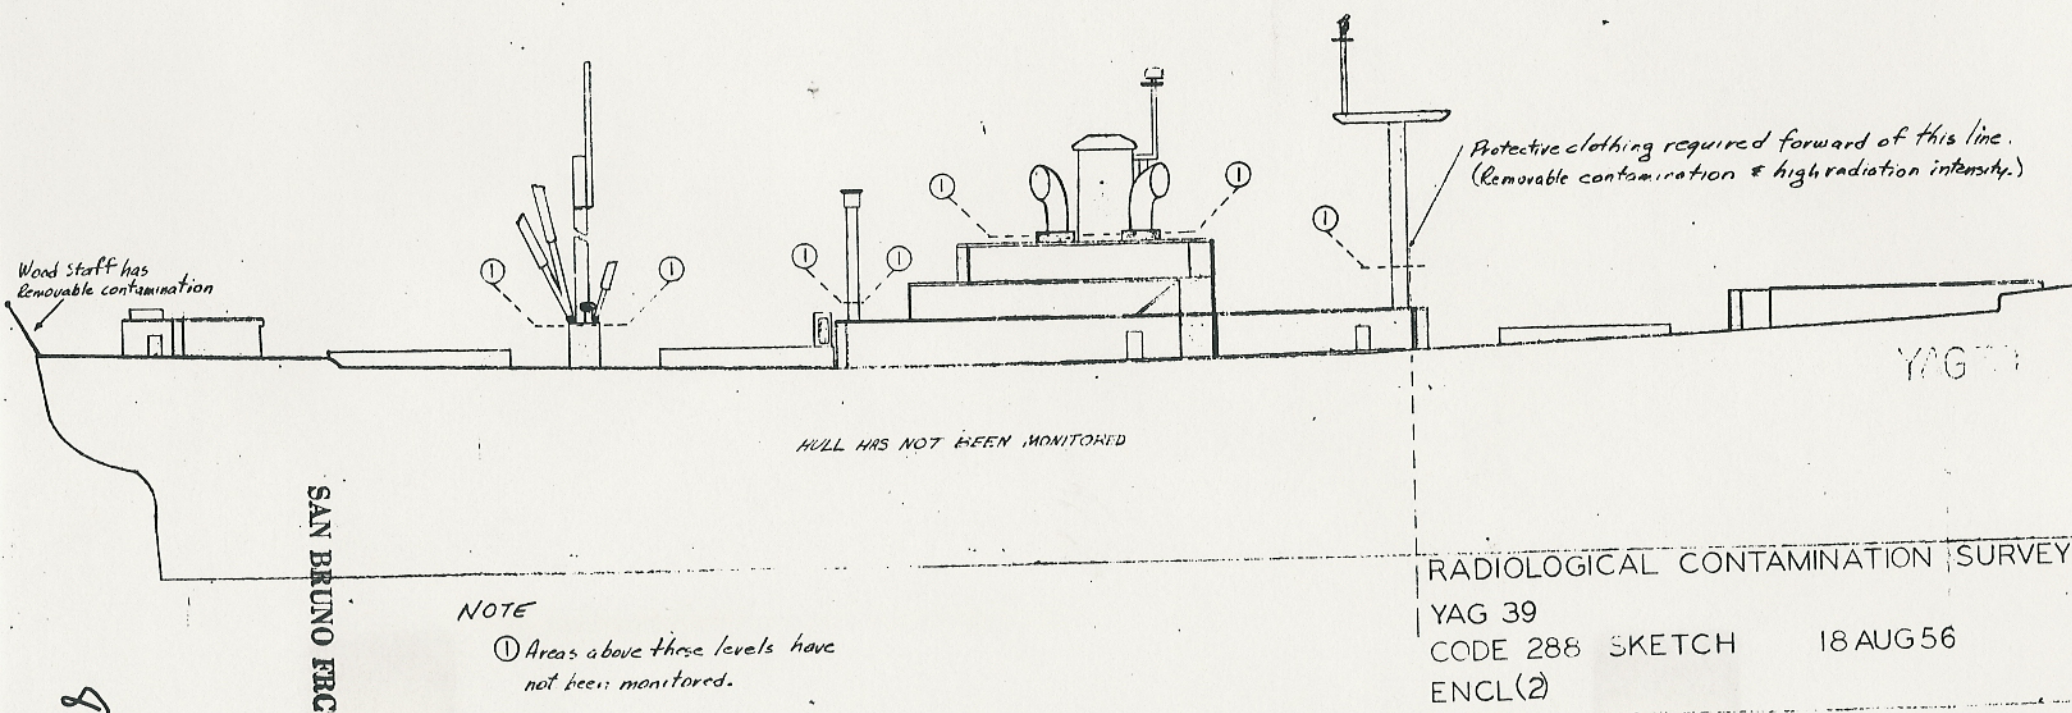
3. The average level of radiation on the weather deck surfaces of the ship aft of the Hold #3 area are less than 2 mr/hr at three feet. Overboard drains and scuppers read somewhat higher.

4. Interior spaces of the ship all read less than 1.3 mr/hr, and removable contamination is negligible, with only one exception. The boiler casing space on the main deck inside the superstructure has two 'hot-spots', one forward and one aft of the stack. Readings to 20 mrep/hr were found, but not removable.

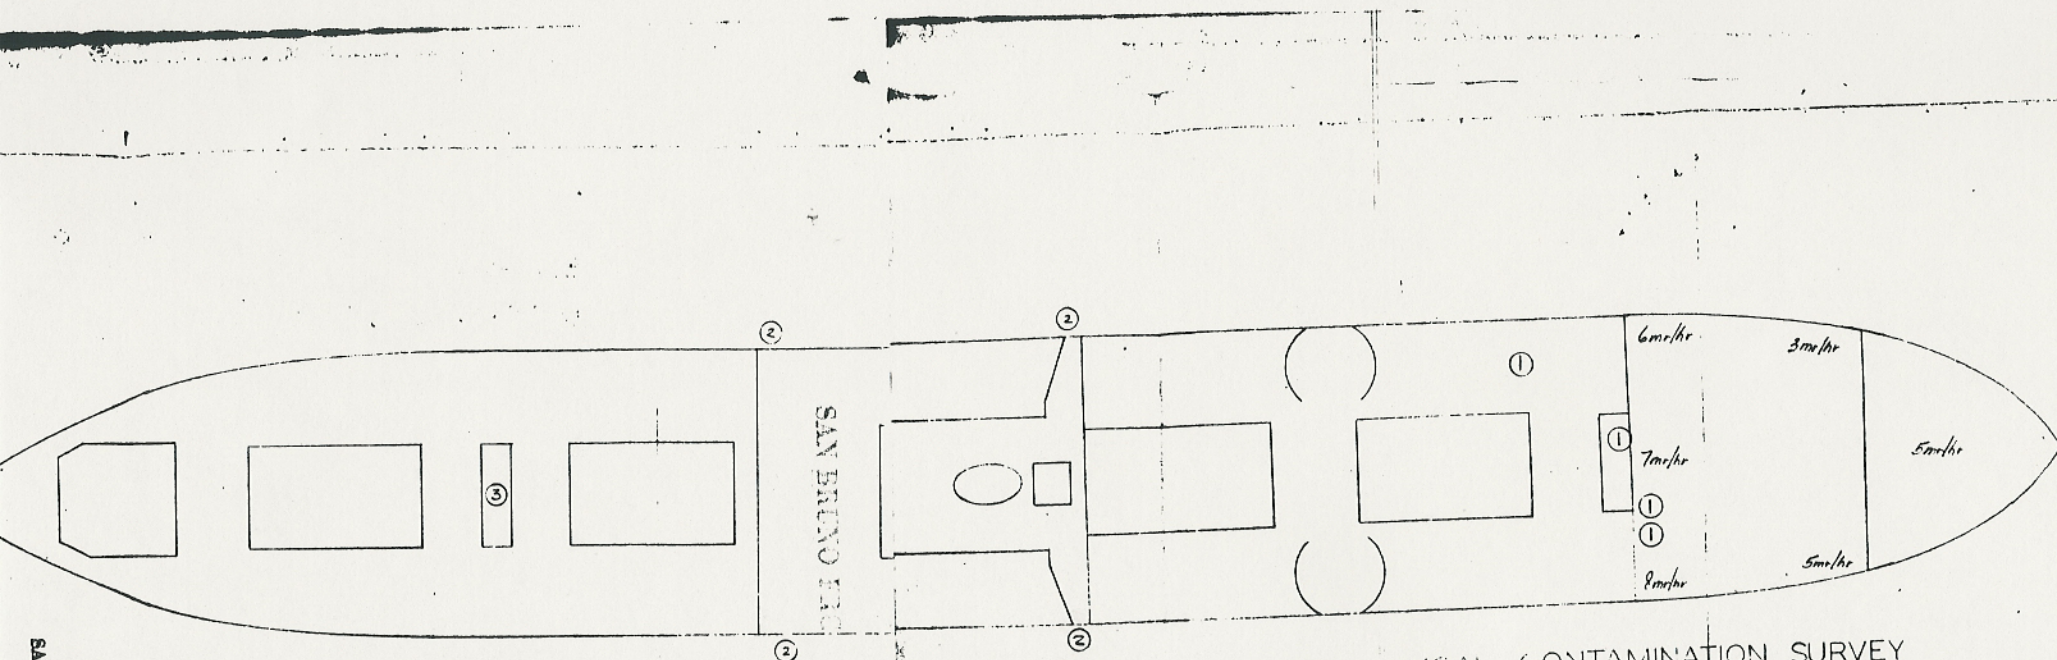
RADIOLOGICAL CONTAMINATION SURVEY
YAG 40
CODE 288 SKETCH 20 AUG 56
ENCL (3)

1. The weather deck surfaces of the ship have been washed down (decontaminated to an extent) and repainted. Wipe testing of these areas revealed negligible amounts of removable contamination.
2. Enclosures (1) and (2) show the radiological status of the weather deck areas of this vessel.
3. The average level of radiation from the helicopter landing platform forward, including the kingpost area, to the bow averages 5 mr/hr at three feet from the surfaces. Readings to 20 mr/hr and 150 mrep/hr were obtained at close contact in this area.

- ① Excessive removable contamination in the base of equipments at these locations noted.
(Dosimeter 'men' - Sellers Unit - GTR station)
- ② Overboard drains and scuppers - 15 mR/hr at 3' - 5+ mR/hr (OW) abt. (Passways - deck level)
- ③ Base of Kingpost and boom - readings to 120 mR/hr.

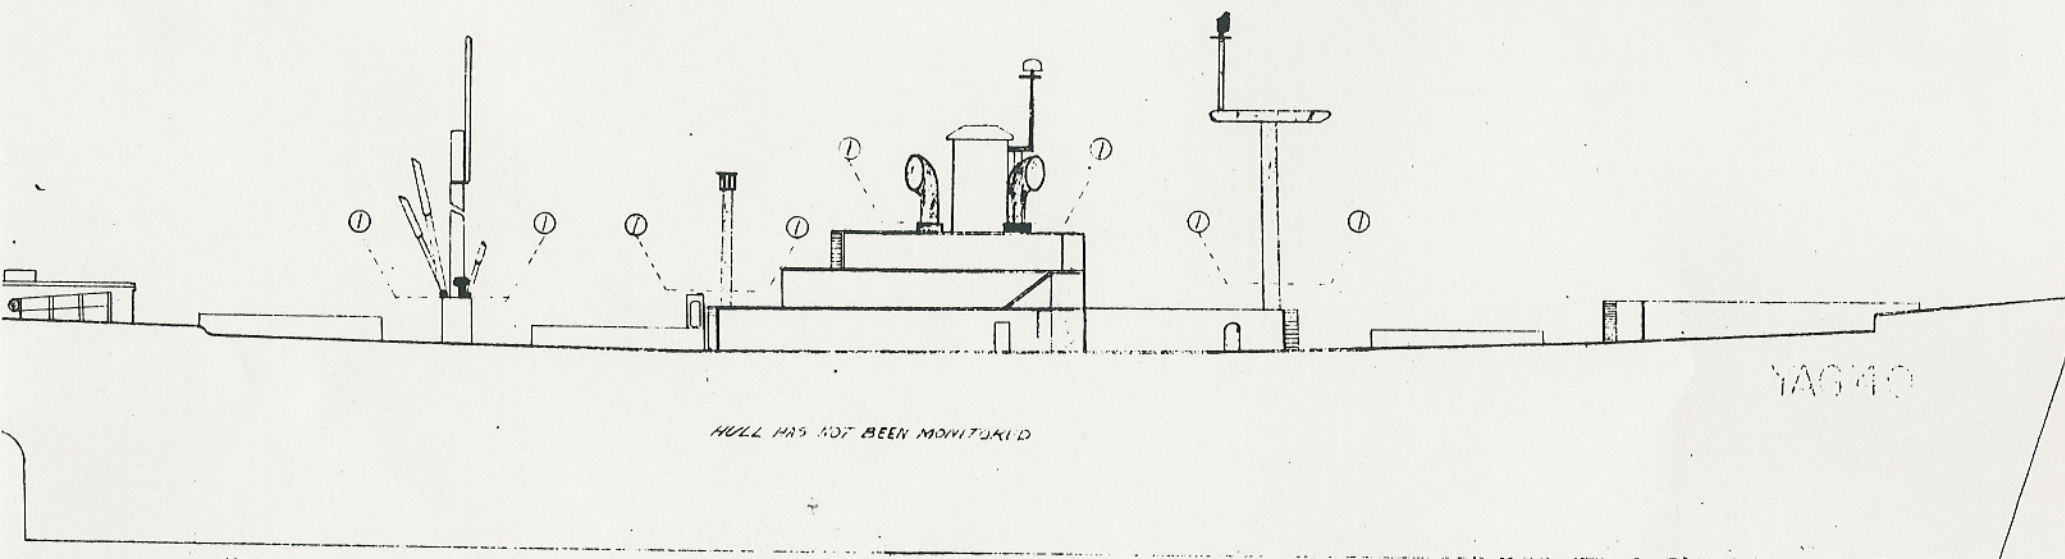
ENCL (4)

4. The average level of radiation on the weather deck aft of the helicopter platform is less than 2 mr/hr. Overboard drains and scuppers read somewhat higher.

① Areas above these levels have not been monitored.
